Service Repair Documentation

Level 2.5 light - S65

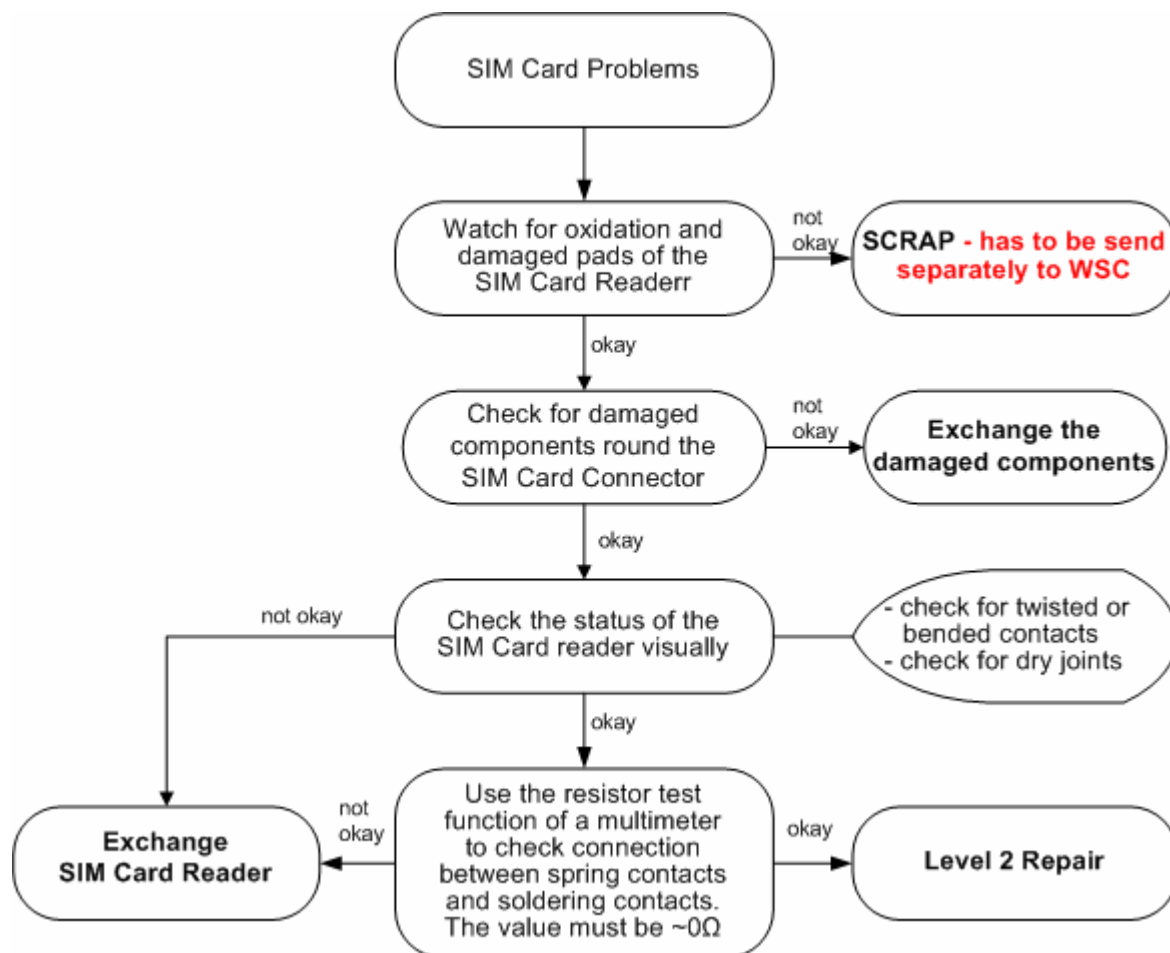
Connector SIM Card Reader

| Fault Symptoms | |
|---|---|
| Customer: Handset does not accept SIM card | GRT: SIM Card Problems |

Use soldering iron to remove defective component. Avoid excessive heat! Watch surrounding components! Resolder new component afterwards.

E-commerce order number: L36334-Z97-C337
Soldering temperature: 240 - 255°C
IRIS Diagnose Code: 43300 Interface/SIM Cardreader/Mechanical Damage

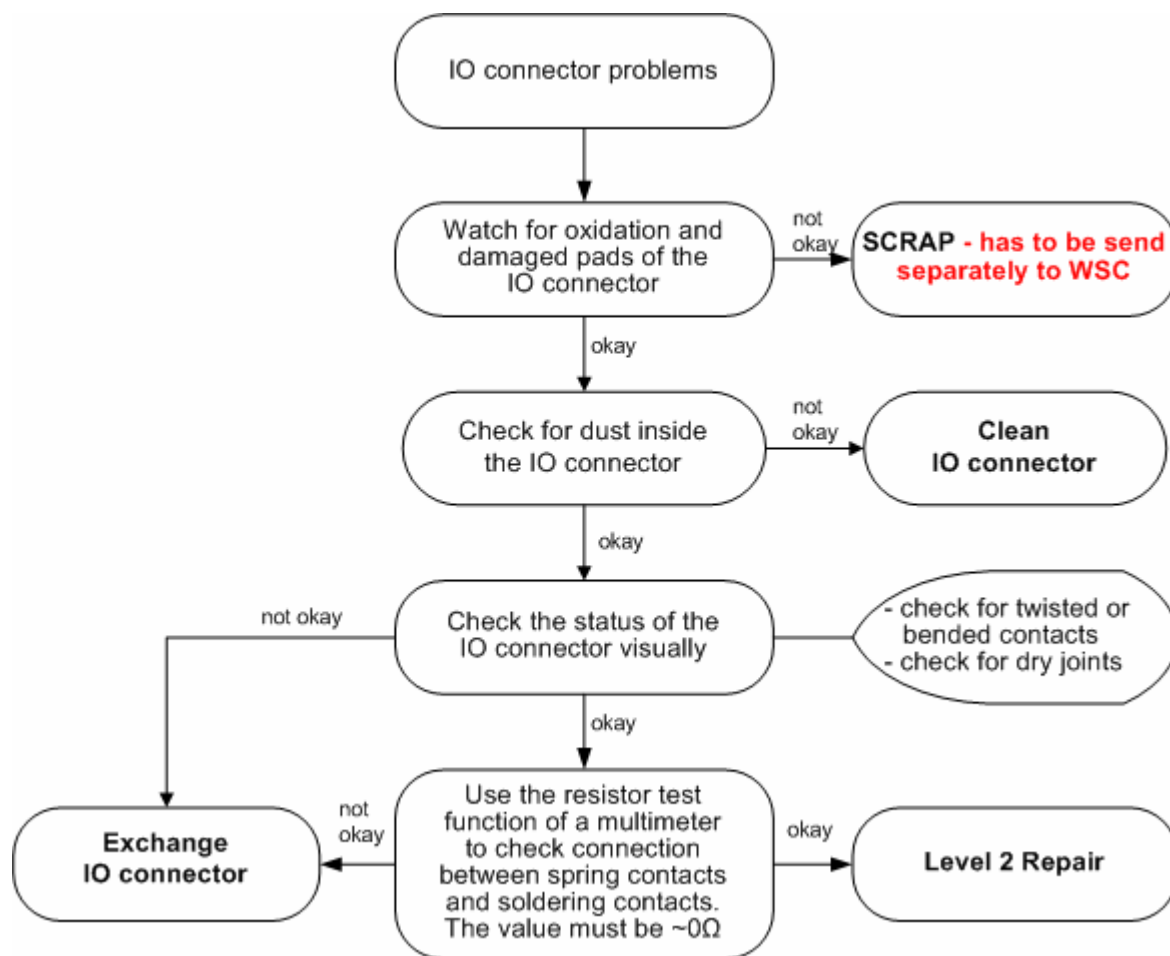
Connector IO Jack

| Fault Symptoms | |
|--|---|
| Customer: Charging Problems Problems with external loudspeaker or microphone when using a car kit Problems with accessories connected at the IO connector | GRT: No connection to GRT Tbd. |

Use soldering iron to remove defective component. Avoid excessive heat! Watch surrounding components! Resolder new component afterwards.

E-commerce order number: L36334-Z93-C303
Soldering temperature: 240 - 255°C
IRIS Diagnose Code: 46100 Interface/Charging Connector/Mechanical Damage
47300 Interface/Data Interface/Mechanical Damage
4B100 Interface/Headset Connector/Mechanical Damage

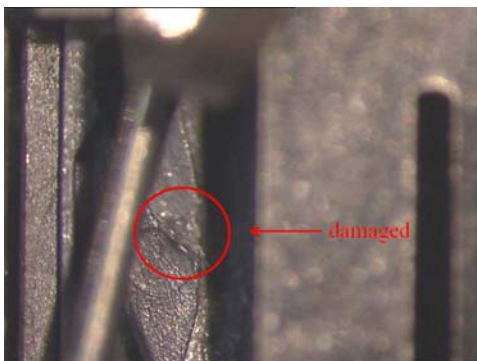
The MMC Reader is located on the opposite of the SLIM-Lumberg connector. Therefore the risk to damage the plastic material of this MMC-Reader is potentially high if excessive heat is used while removal or soldering of the SLIM-Lumberg connector.

Lock mechanism damaged

- a) Remove the SLIM-Lumberg connector with a soldering iron and Desolder Wick
- b) Clean the Pads afterwards
- c) Solder the new connector by using soldering iron under consideration of the max. allowed temperature range.

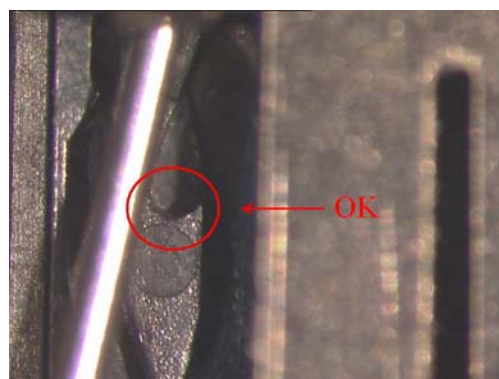
Lock mechanism OK

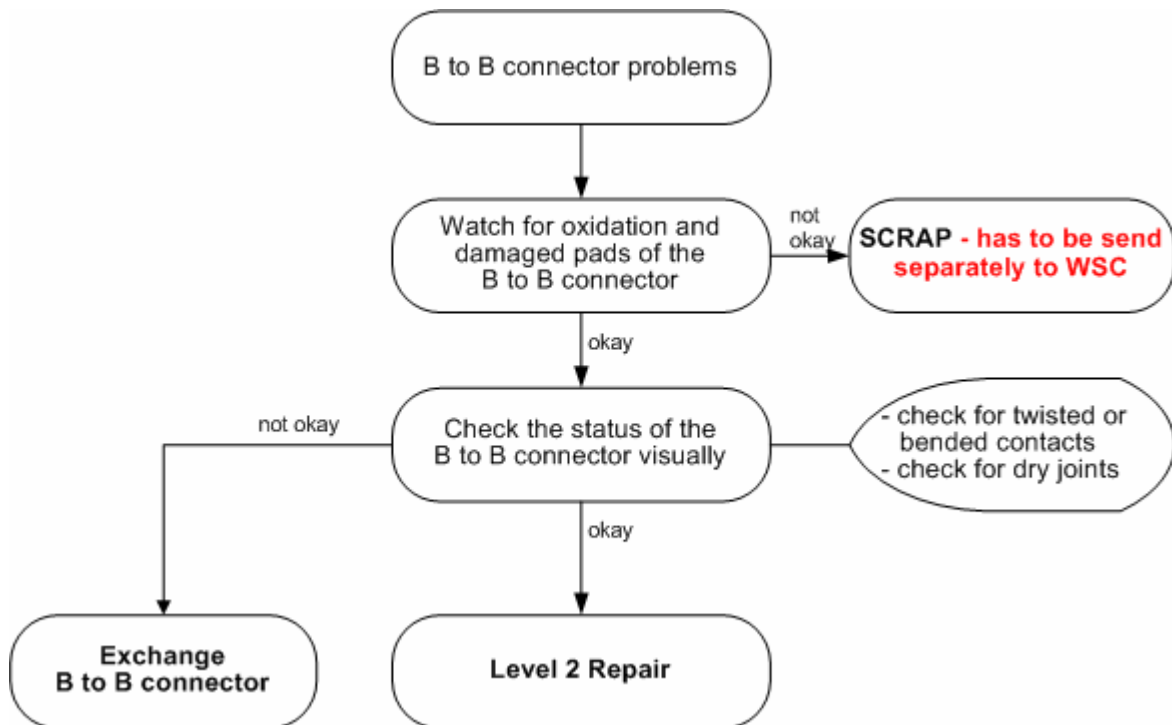
Connector Board to Board

| Fault Symptoms | |
|--|---|
| Customer: Keyboard malfunction Keypad illumination does not work | GRT: Keyboard malfunction Tbd. |

Use hot air blower to remove defective component. Avoid excessive heat! Watch surrounding components! Resolder new component afterwards.

E-commerce order number: L36334-Z97-C346
Soldering temperature: 240 - 255°C
IRIS Diagnose Code: 32100 Keys / Main / No Function
32200 Keys / Main / Reduced Functionality
36000 Keys / Illumination

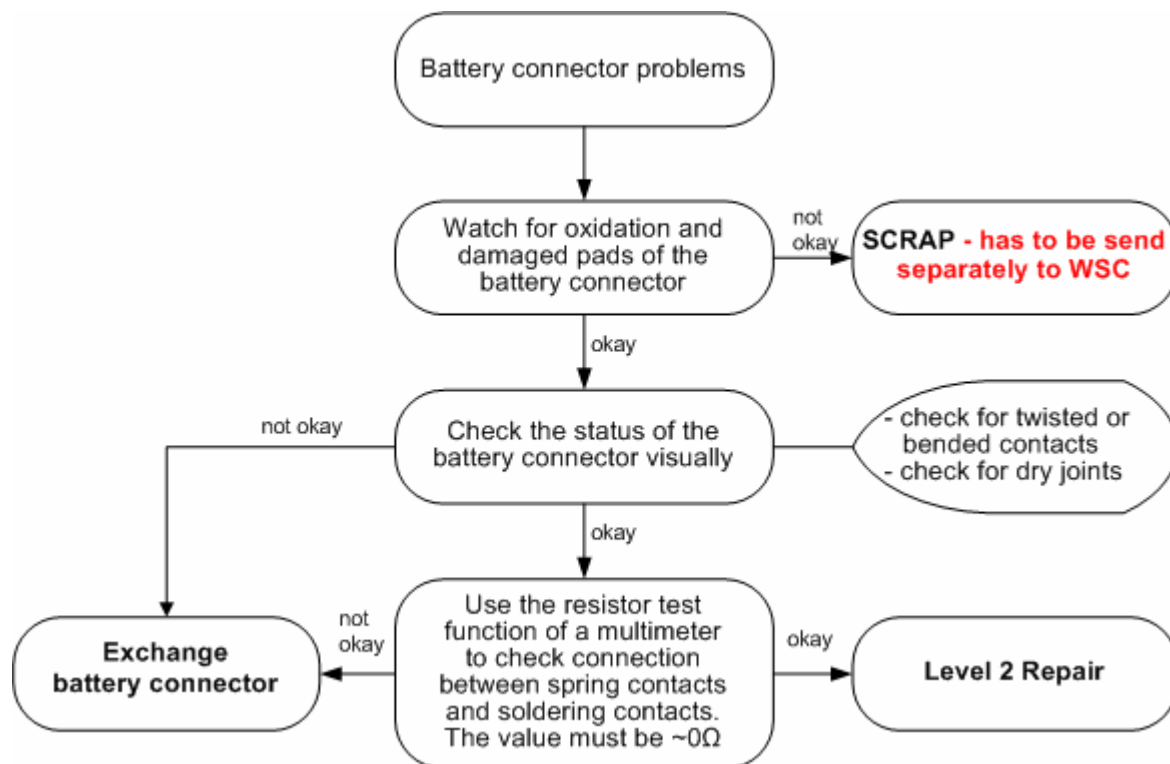
Connector BATTERY

| Fault Symptoms | |
|--|---|
| Customer: Mobile does not switch on | GRT: No connection to GRT |

Use hot air blower to remove defective component. Avoid excessive heat! Watch surrounding components! Resolder new component afterwards.

E-commerce order number: L36334-Z97-C213
Soldering temperature: 240 - 255°C
IRIS Diagnose Code: 13000 Battery/Mechanical Damage

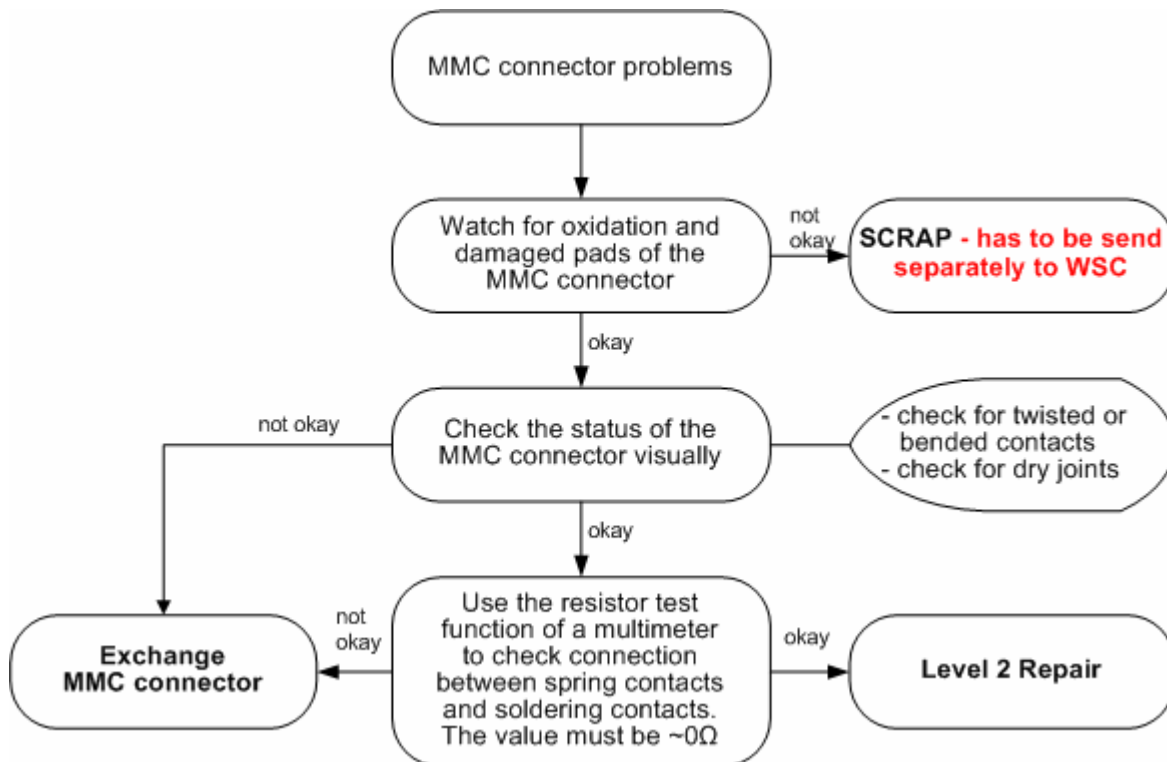
Connector MMC

| Fault Symptoms | |
|---|---|
| Customer: MMC malfunction | GRT: Tbd. |

Use soldering iron to remove defective component. Avoid excessive heat! Watch surrounding components! Resolder new component afterwards.

E-commerce order number: L36334-Z97-C342
Soldering temperature: 240 - 255°C
IRIS Diagnose Code: B1120 Accessories / Memory / MMC / Defect

Attention: Avoid excessive heat in order not to damage the plastic material of the connector (see problem SLIM-Lumberg connector)

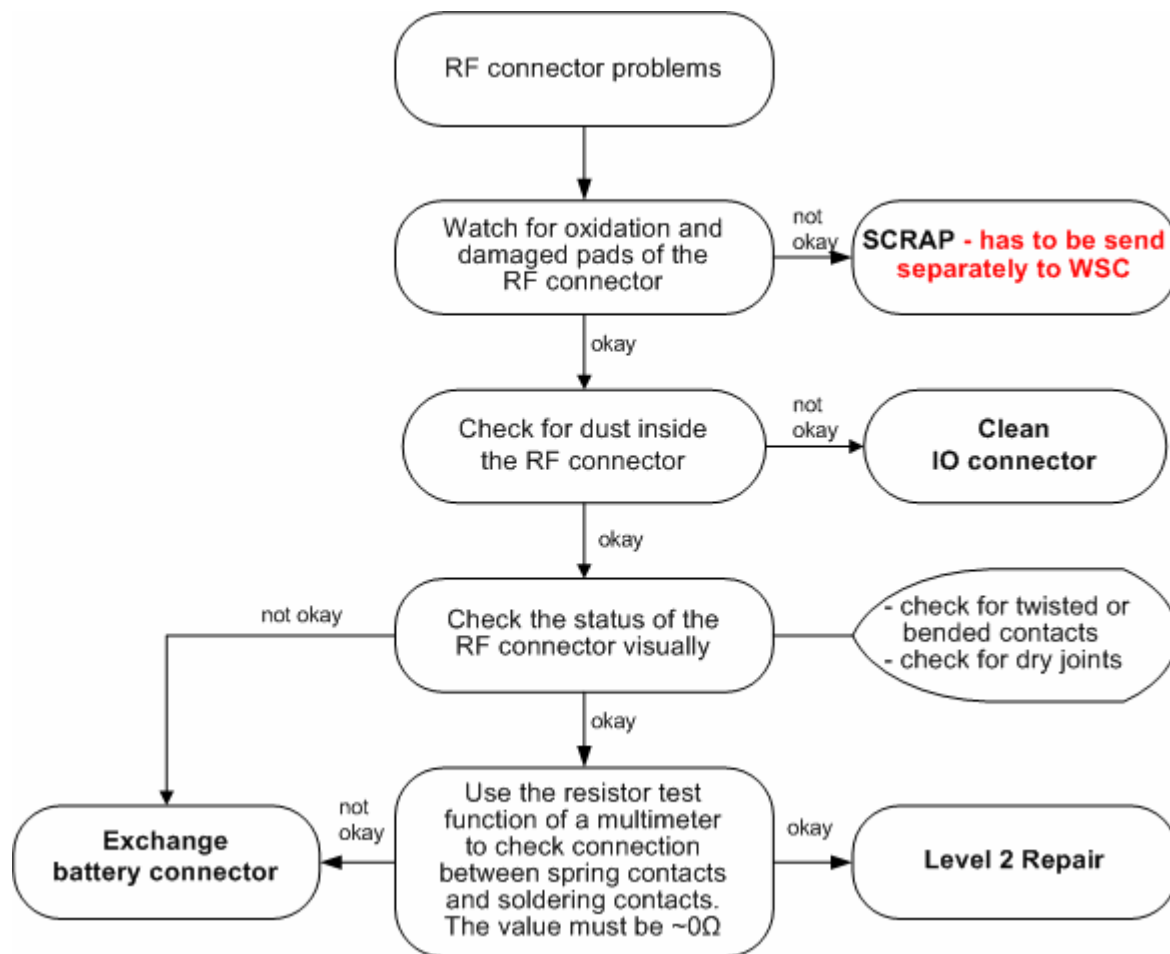
Connector RF

| Fault Symptoms | |
|--|--|
| Customer: Network search No location update possible | GRT: Failure by TX/RX measurements No location update possible |

Use hot air blower to remove defective component. Avoid excessive heat! Watch surrounding components! Resolder new component afterwards.

E-commerce order number: L36334-Z93-C297

Soldering temperature: 240 - 255°C

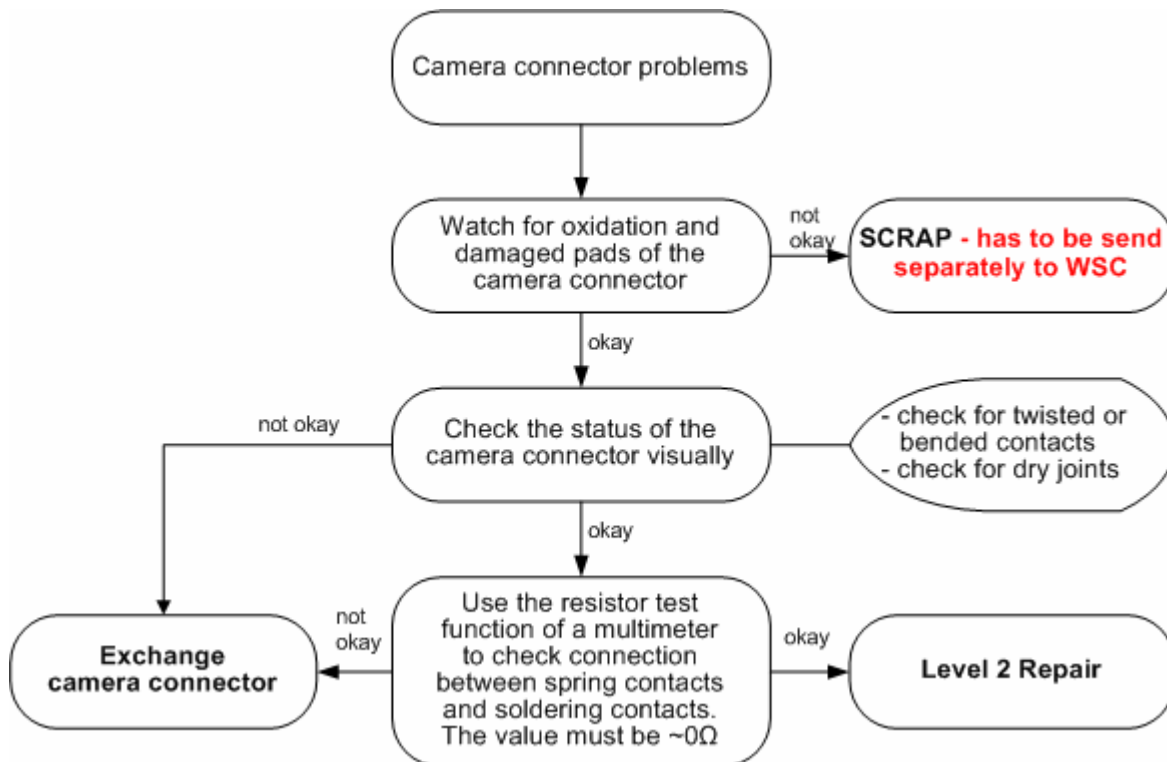
Connector CAMERA

| Fault Symptoms | |
|---|---|
| Customer: Camera malfunction | GRT: Tbd. |

Use hot air blower to remove defective component. Avoid excessive heat! Watch surrounding components! Resolder new component afterwards.

E-commerce order number: L36197-F5008-F341
Soldering temperature: 240 - 255°C
IRIS Diagnose Code: BA000 Accessories / Camera

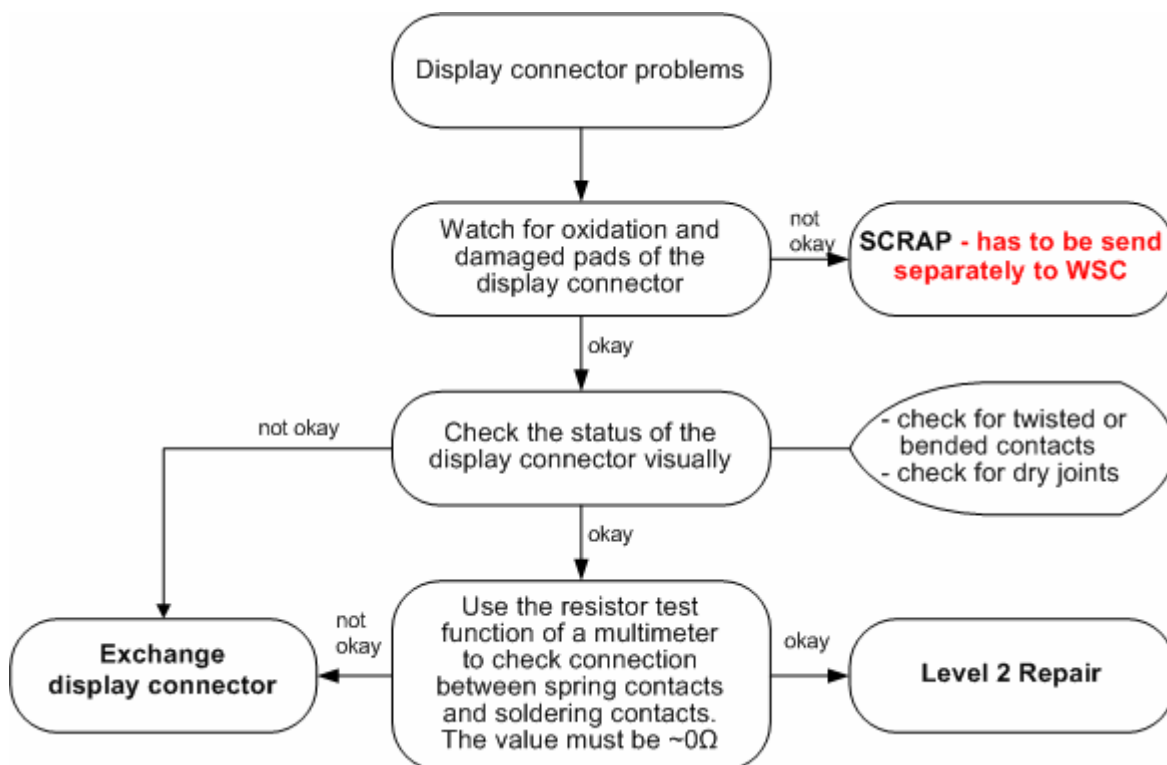
Connector DISPLAY

| Fault Symptoms | |
|---|---|
| Customer: Display problems, like missing lines or columns on the LCD or display contrast problems or illumination problems | GRT: Display problems |

Use hot air blower to remove defective component. Avoid excessive heat! Watch surrounding components! Resolder new component afterwards.

E-commerce order number: L36334-Z97-C205
Soldering temperature: 240 - 255°C
IRIS Diagnose Code: 21000 Display / Performance
22000 Display / Background Illumination

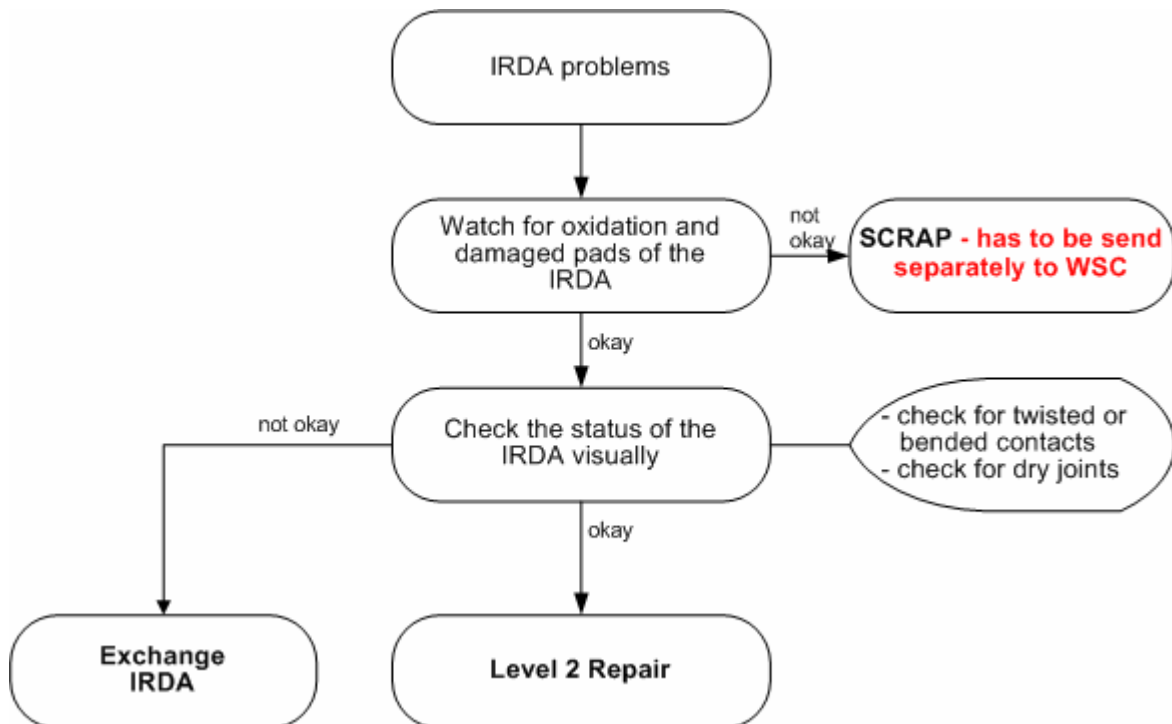
| Fault Symptoms | |
|--|---|
| Customer: No infrared connection possible | GRT: Tbd. |

Use hot air blower to remove defective component. Avoid excessive heat! Watch surrounding components!
Resolder new component afterwards.

E-commerce order number: L36810-U6130-D670
Soldering temperature: 240 - 255°C
IRIS Diagnose Code: 41100 Interfaces / IRDA / No Function
41300 Interfaces / IRDA / Mechanical Damage

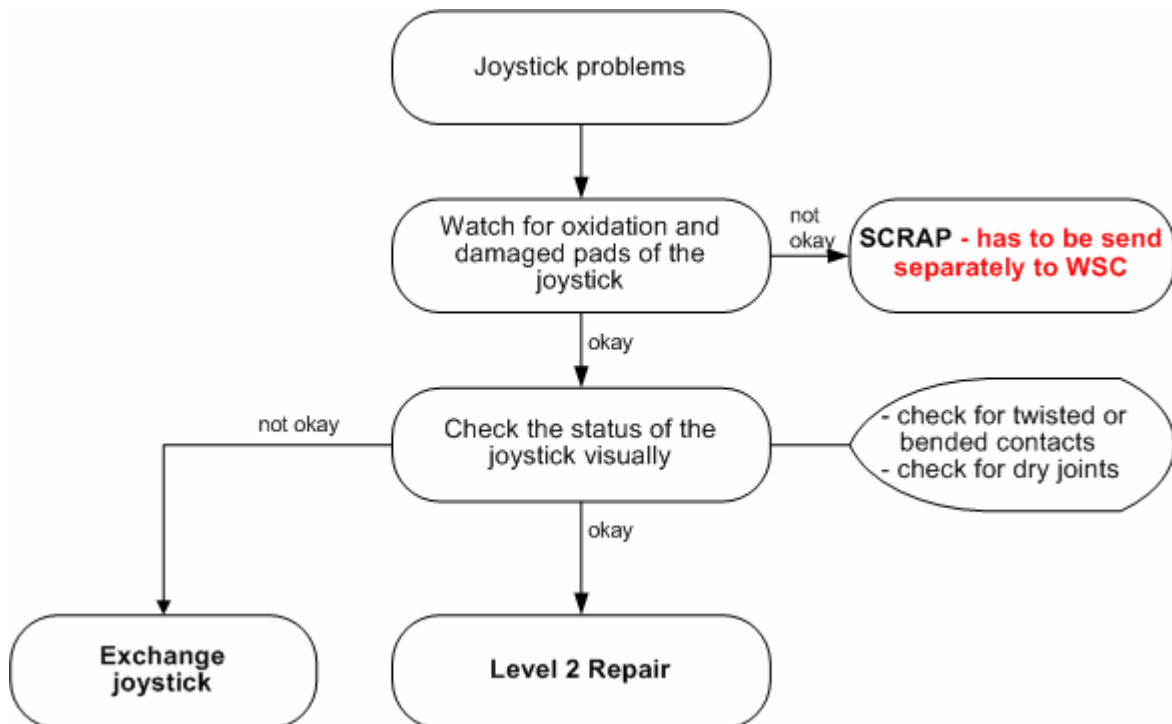
| Fault Symptoms | |
|---|---|
| Customer: Joystick malfunction | GRT: Tbd. |

Use hot air blower to remove defective component. Avoid excessive heat! Watch surrounding components! Resolder new component afterwards.

E-commerce order number: L36315-Z77-C218
Soldering temperature: 240 - 255°C
IRIS Diagnose Code: 32100 Keys / Main / No Function
32200 Keys / Main / Reduced Functionality
