# Service Repair Documentation

## Level 2.5 - SL65

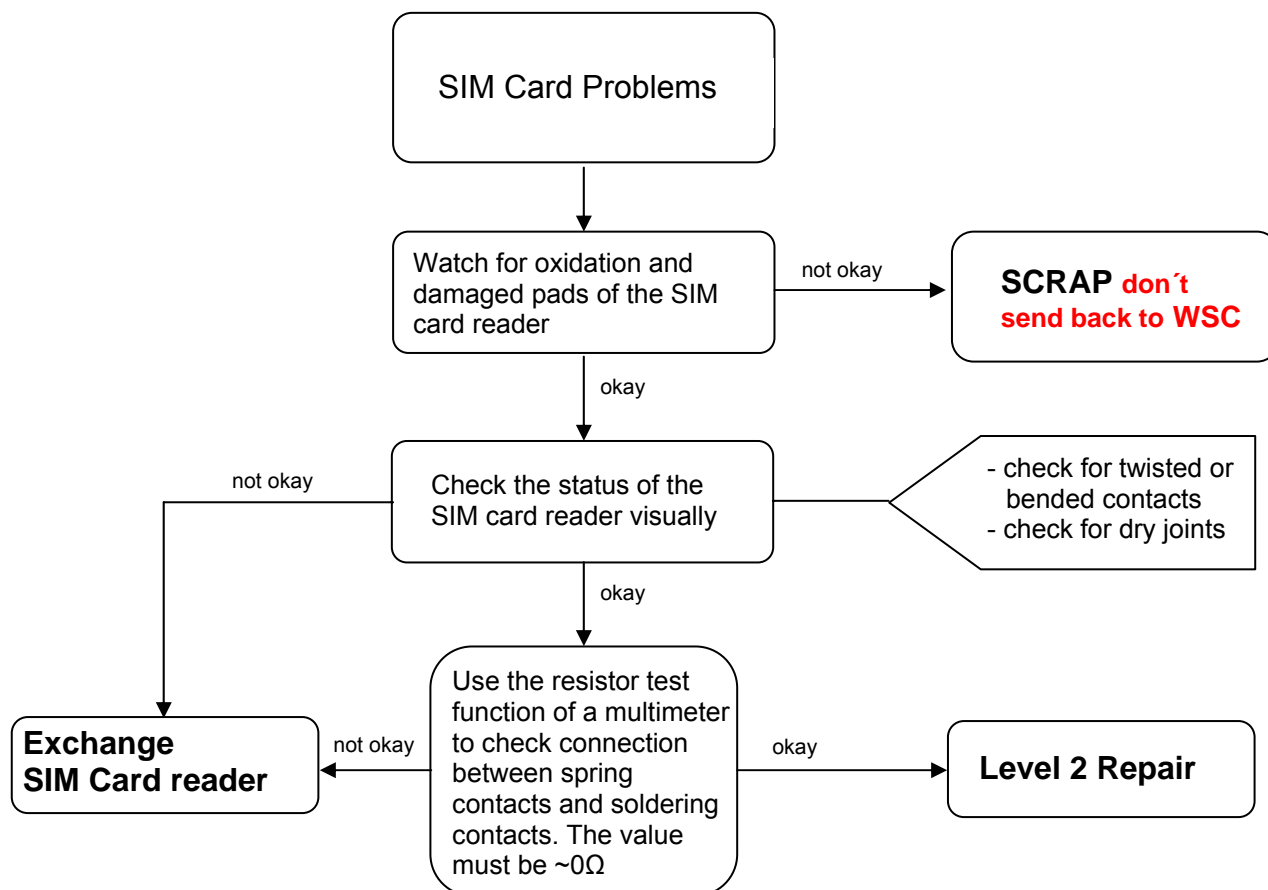
### Connector SIM Card Reader

Fault Symptoms	
Customer: Handset does not accept SIM card	GRT: SIM Card Problems

Use soldering iron to remove defective component. Avoid excessive heat! Watch surrounding components! Resolder new component afterwards.

E-commerce order number: L36334-Z97-C335  
Soldering temperature: 240 - 255°C  
IRIS Diagnose Code: 43300 Interface/SIM Cardreader/Mechanical Damage

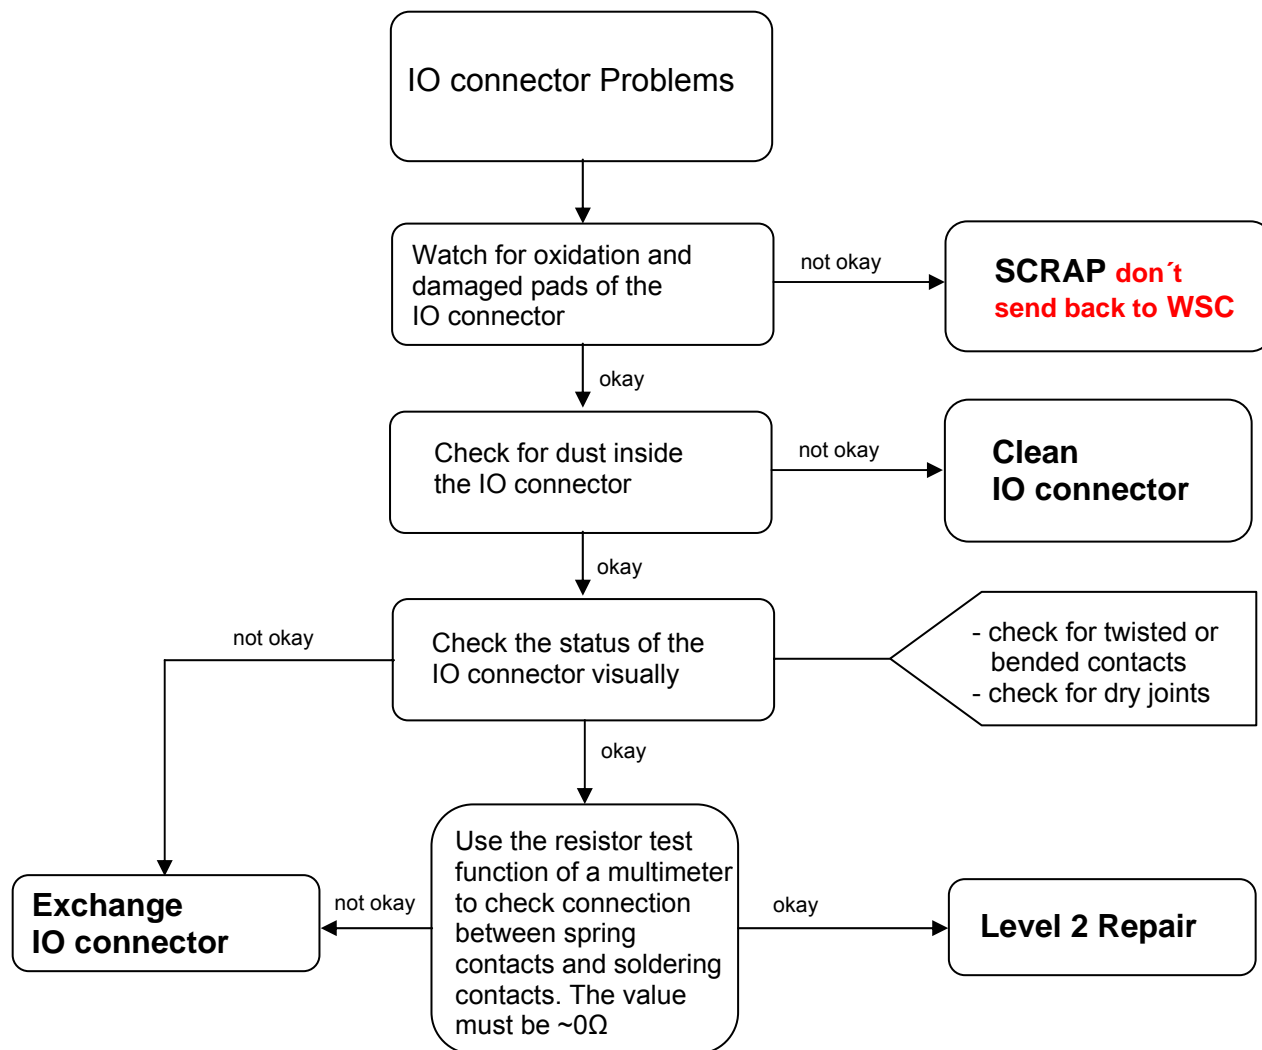
#### Connector IO Jack

Fault Symptoms	
Customer: Charging Problems Problems with external loudspeaker or microphone when using a car kit Problems with accessories connected at the IO connector	GRT: No connection to GRT Tbd.

Use soldering iron to remove defective component. Avoid excessive heat! Watch surrounding components!  
Resolder new component afterwards.

E-commerce order number: L36334-Z93-C303  
Soldering temperature: 240 - 255°C  
IRIS Diagnose Code: 46100 Interface/Charging Connector/Mechanical Damage  
47300 Interface/Data Interface/Mechanical Damage  
4B100 Interface/Headset Connector/Mechanical Damage

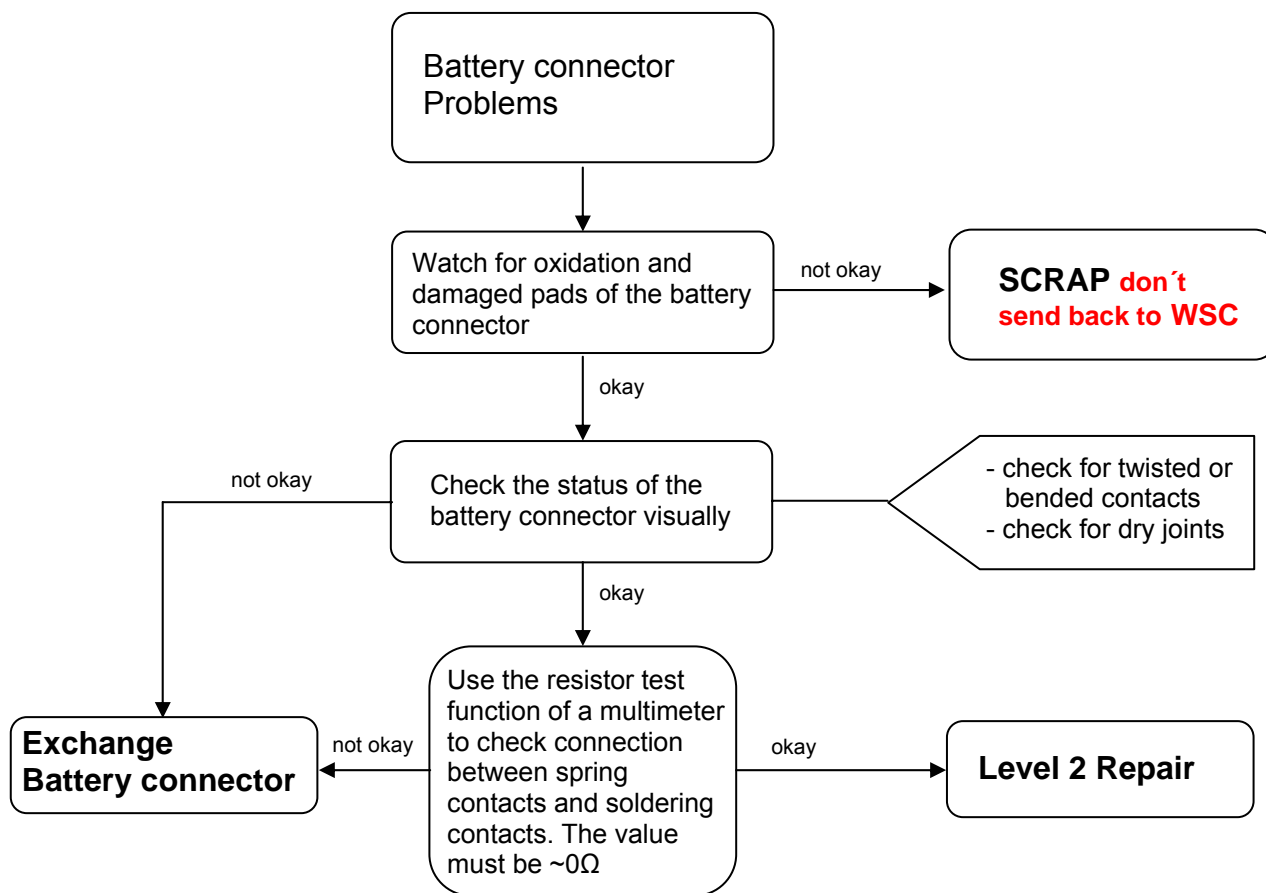
### Connector BATTERY

Fault Symptoms	
Customer: Mobile does not switch on	GRT: No connection to GRT

Use hot air blower to remove defective component. Avoid excessive heat! Watch surrounding components! Resolder new component afterwards.

E-commerce order number: L36334-Z97-C213  
Soldering temperature: 240 - 255°C  
IRIS Diagnose Code: 13000 Battery/Mechanical Damage

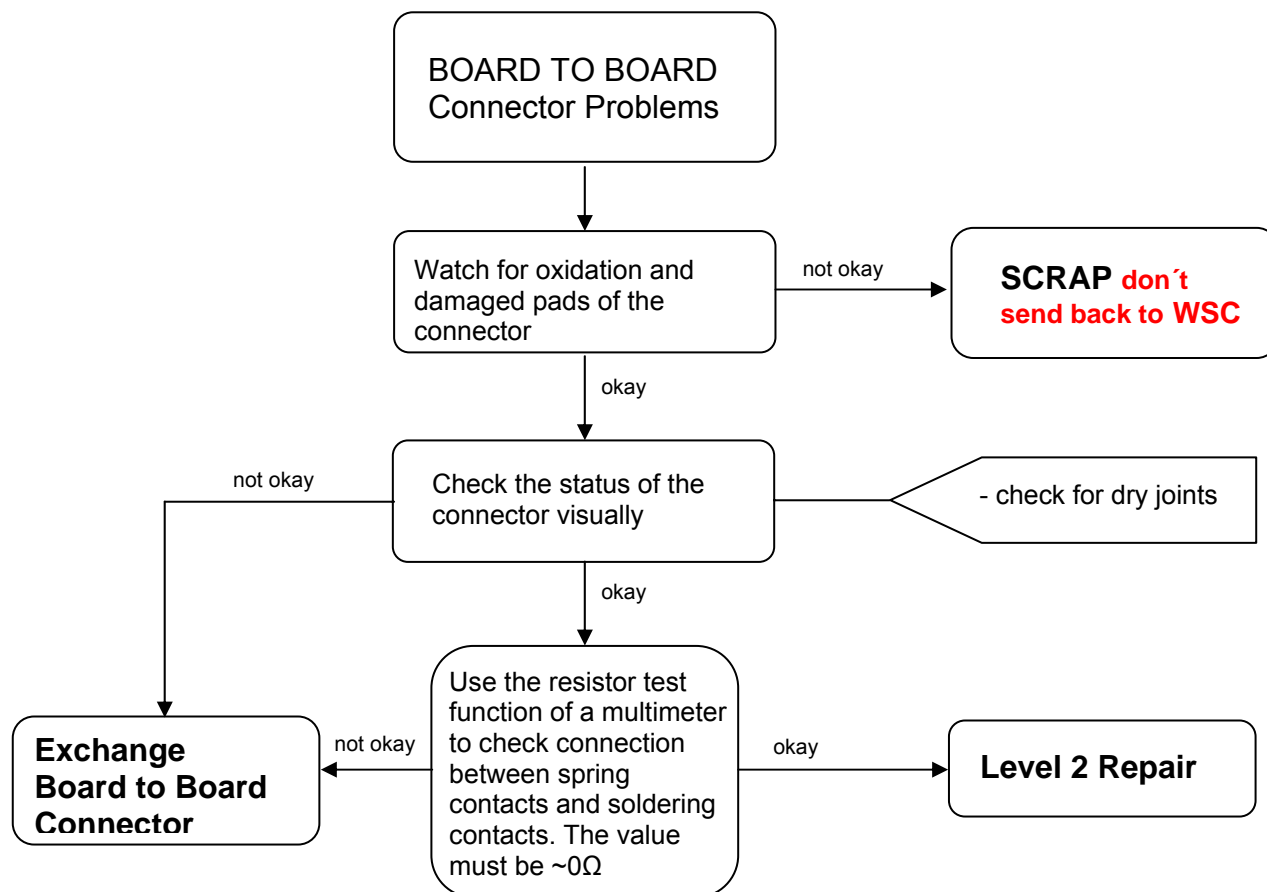
### Connector BOARD TO BOARD

Fault Symptoms	
Customer: Display problems, like missing lines or columns on the LCD or display contrast problems or illumination problems No infrared connection possible Joystick malfunction	GRT: Display problems  Tbd. Tbd.

Use soldering iron to remove defective component. Avoid excessive heat! Watch surrounding components!  
Resolder new component afterwards.

E-commerce order number: L36 334-Z97-C340  
Soldering temperature: 240 - 255°C  
IRIS Diagnose Code:  
21000 Display / Performance  
22000 Display / Background Illumination  
41100 Interfaces / IRDA / No Function  
41300 Interfaces / IRDA / Mechanical Damage  
32100 Keys / Main / No Function  
32200 Keys / Main / Reduced Functionality

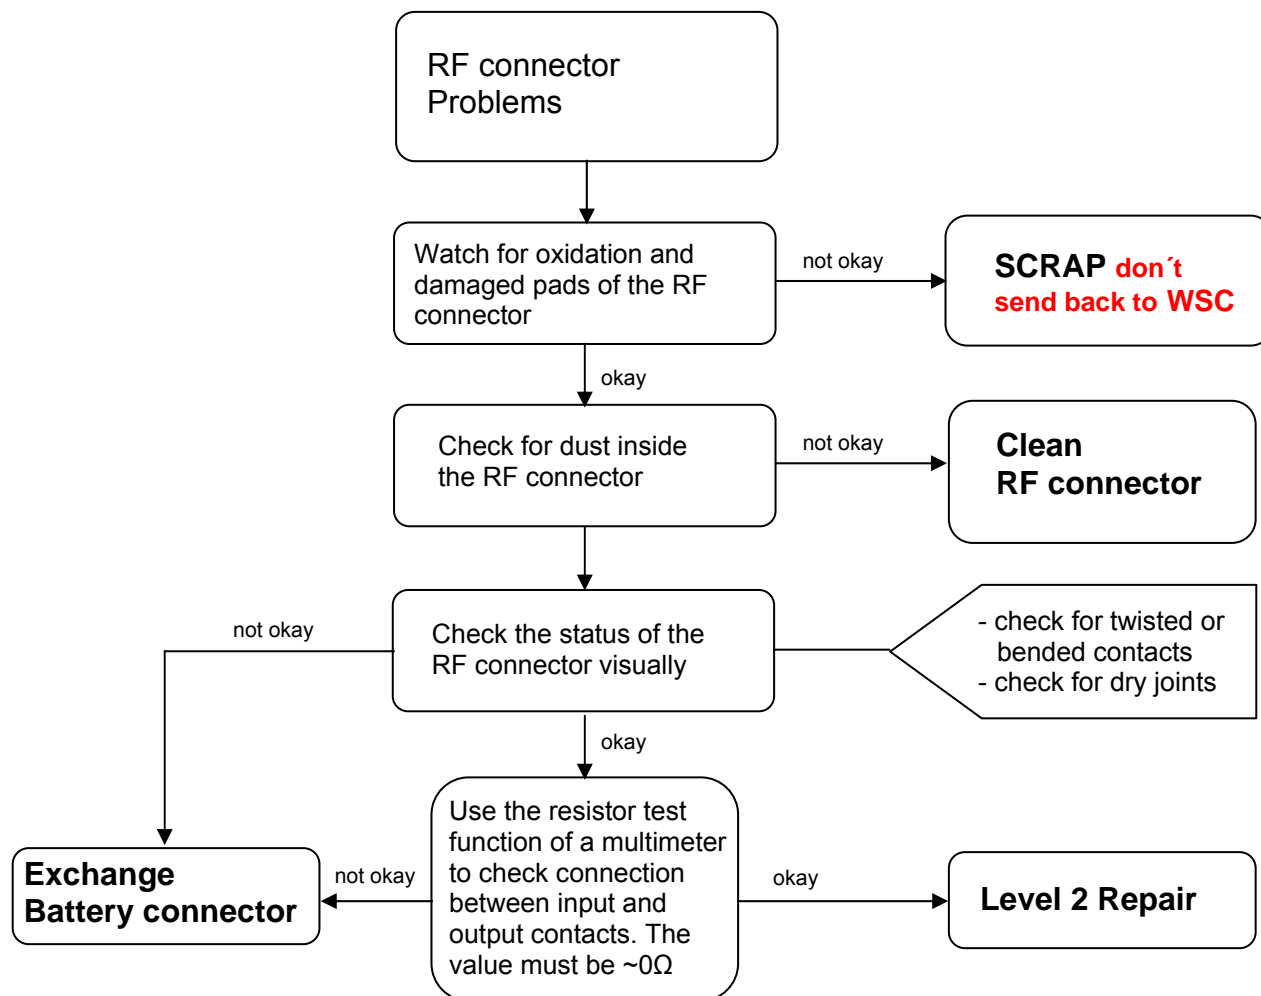
### Connector RF

Fault Symptoms	
Customer: Network search No location update possible	GRT: Failure by TX/RX measurements No location update possible

Use hot air blower to remove defective component. Avoid excessive heat! Watch surrounding components! Resolder new component afterwards.

E-commerce order number: L36197-F5020-F650

Soldering temperature: 240 - 255°C

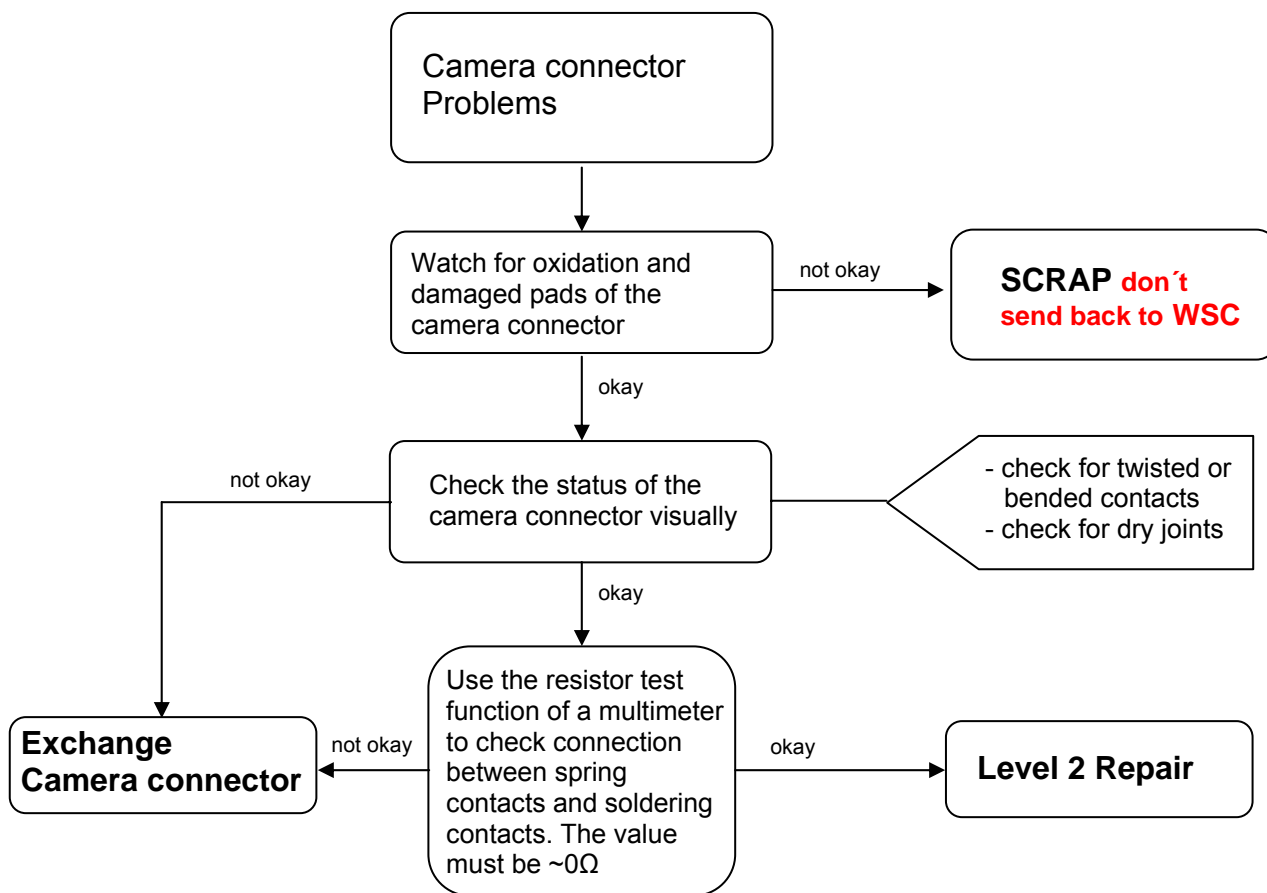
### Connector CAMERA

Fault Symptoms	
Customer: Camera malfunction	GRT: Tbd.

Use hot air blower to remove defective component. Avoid excessive heat! Watch surrounding components! Resolder new component afterwards.

E-commerce order number: L36197-F5008-F341  
Soldering temperature: 240 - 255°C  
IRIS Diagnose Code: BA000 Accessories / Camera
