XELIBRI X1

LEVEL 2.5

REPAIR DOCUMENTATION

V 1.0

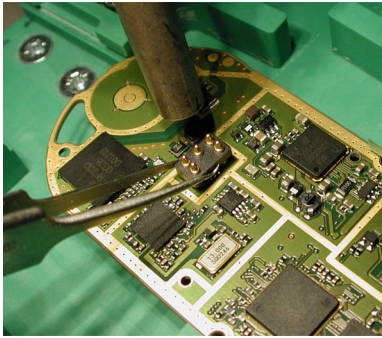
<p>Figure 2-1</p>	Use a hot air blower to remove the defective battery connector. Avoid excessive heat! Watch surrounding components!!	
2

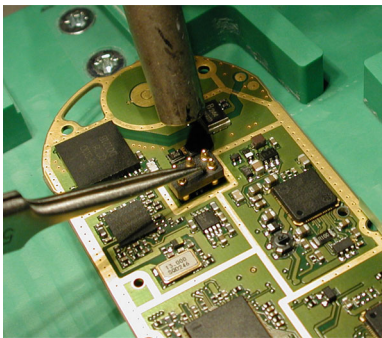
<p>Figure 2-2</p>	Re-solder the new battery connector by using a hot air blower. Check that the connector is straight and exactly in right place.

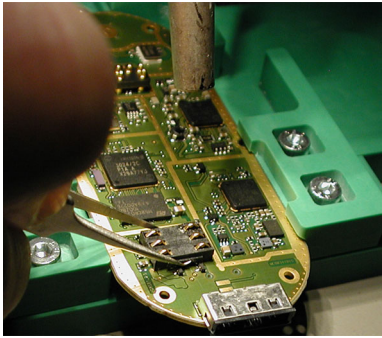
<p>Figure 3-1</p>	Use a hot air blower to remove the defective SIM card reader. Avoid excessive heat! Watch surrounding components!!	
2

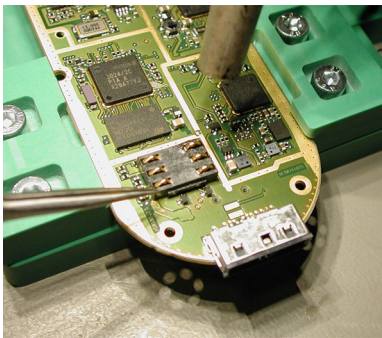
<p>Figure 3-2</p>	Re-solder the new SIM card reader by using a hot air blower. Check that the SIM card reader is straight and exactly in right place.

- Measure VSIM (2.75 V - 3.3 V) from capacitor R186. Voltage appears only for a short time if a SIM card is not inserted when the phone is switched on, and when a SIM card is inserted, present voltage should stay constantly approx. 2.9 V when the power is on.
- SIMCLK on V181 pin 1. This signal will only appear if a SIM card is inserted and working. The Clock signal is not present always, but will come in intervals.
- SIMDATA on V181 pin 2. This signal will only appear if a SIM card is inserted and working and when SIMCLK is present.

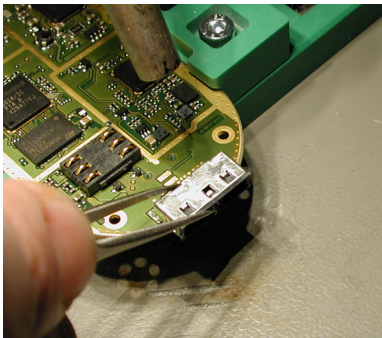
<p>Figure 4-1</p>	Use a hot air blower to remove the defective system connector. Avoid excessive heat! Watch surrounding components!	
2

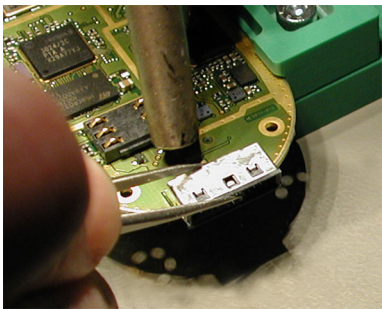
<p>Figure 4-2</p>	Re-solder the new system connector by using a hot air blower, and a soldering iron if necessary. Check that the system connector is straight and exactly in right place.

Charging problems can be discovered by measuring the voltage between pins 1 (Power) and 2 (GND). Voltage should be between 5V and 9,5V if system connector is working.

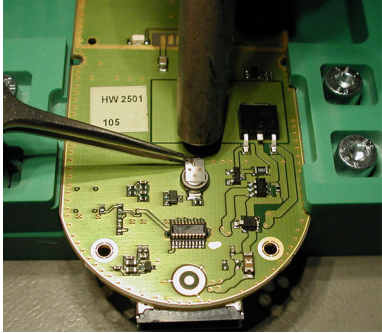
<p>Figure 5-1</p>	Use a hot air blower to remove the defective RTC battery. Avoid excessive heat! Watch surrounding components!	
2

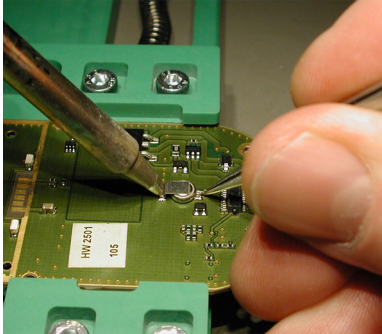
<p>Figure 5-2</p>	Resolder the new RTC battery by using a hot air blower and a soldering iron if necessary. Check that the RTC battery is exactly in right place. Watch surrounding components!

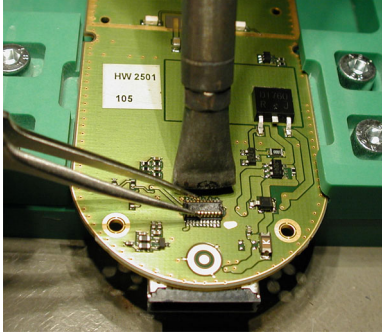
<p>Figure 6-1</p>	Use a hot air blower to remove the defective keymat connector. Avoid excessive heat! Watch surrounding components!	
2		Resolder the new keymat connector by using a hot air blower and a soldering iron if necessary. Check that the keymat connector is straight and exactly in right place. Watch surrounding components!

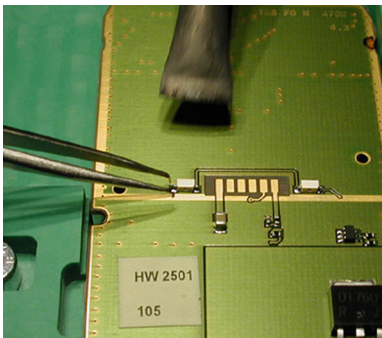
<p>Figure 7-1</p>	Use a hot air blower to remove the defective display LED. Avoid excessive heat! Watch surrounding components!	
2

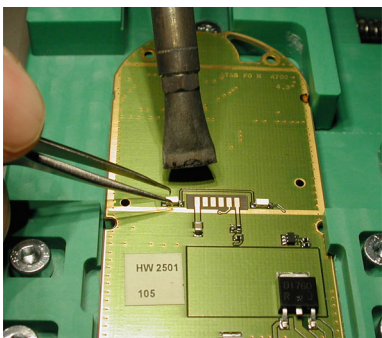
<p>Figure 7-2</p>	Re-solder the new display LED by using a hot air blower and a soldering iron if necessary. Watch surrounding components!
