Component Replacement - electrical -

Xperia™ E5
F3311, F3313

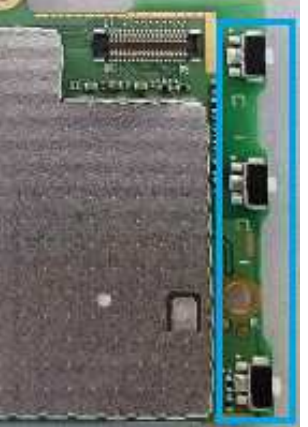
SW1901 SW1902 SW1903

The Component direction is shown by using red or black point.

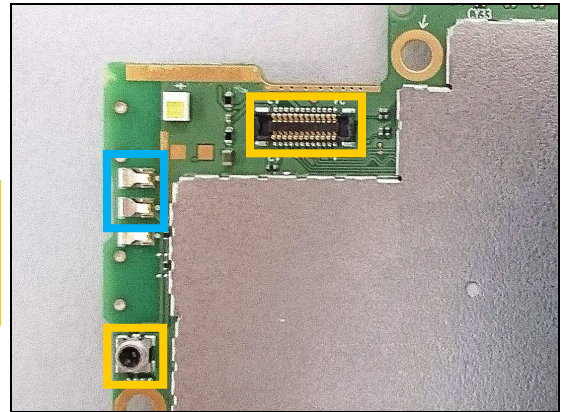
ANT2501, ANT2503

Replace if mechanical damaged.

(No or bad WLAN/ BT/ GPS)

Protect the RF connector and the BtB connector with capton tape!

Position	Component	Part no.	Comments
ANT2501	SPR CONN TM010-307 JTCONN	2313000161W	S HA+BH ⇨1
ANT2503	SPR CONN TM010-307 JTCONN	2313000161W	S HA+BH ⇨1
CON2501	RF SWITCH C90P103-00005-H SPEED	2302000040W	S HA+BH ⇨2
D1202	LED	1770000143W	S HA+BH ⇨3
FJP2301	COAX CONN C89P119-10001-H SPEED	2335000029W	S HA+BH ⇨4
GP2601	SPR Connector	2313000105W	S HA+BH ⇨5
GP2602	SPR Connector	2313000105W	S HA+BH ⇨5
J1001	BATT CONN	2303000119W	S HA+BH ⇨6
J1601	AUDIOJACK AJ034-27323A01D JTCONN	23110000100	P HA/ST+BH ⇨7
J2801	MEMSOCKET ST11S008V4H JAE	2334000054W	P HA+BH or BGA ⇨8
J2901	Single SIMSOCKET SM049-13116A02D JTCONN	2304000158W	P HA+BH or BGA ⇨9
PAD2401	SPR CONN TM010-307 JTCONN	2313000161W	S HA+BH ⇨10
PAD2403	SPR CONN TM010-307 JTCONN	2313000161W	S HA+BH ⇨10
SMA2301	RF SWITCH C90P103-00005-H SPEED	2302000040W	S HA+BH ⇨11
SMA2401	RF SWITCH C90P103-00005-H SPEED	2302000040W	S HA+BH ⇨12
SW1901	SWITCH	2322000086W	P HA+BH ⇨13

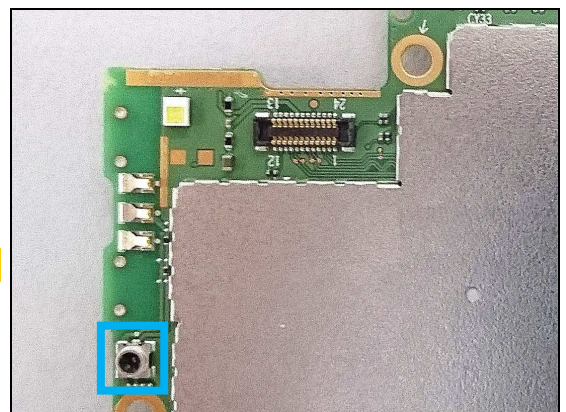
CON2501

Replace if open circuit 1-2 (No or bad WLAN/ BT/ GPS)

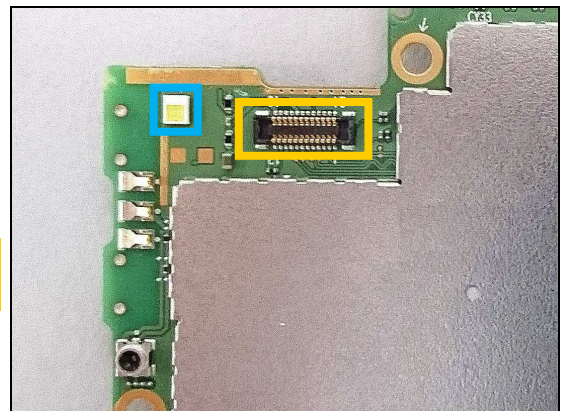
D1202

Replace if Flash LED not working.

Protect the BtB connector with capton tape!

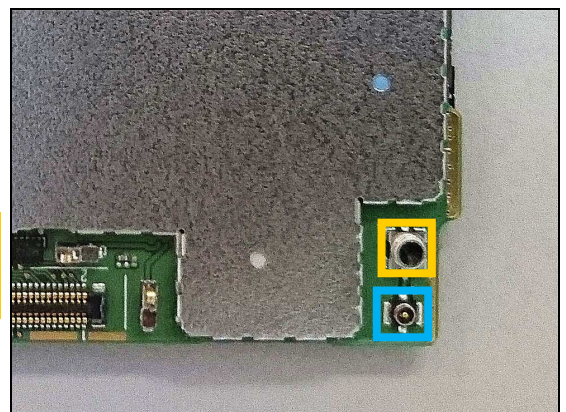
FJP2301

Replace if mechanical damaged (Bad network, Main antenna)

Protect the RF connector with capton tape!

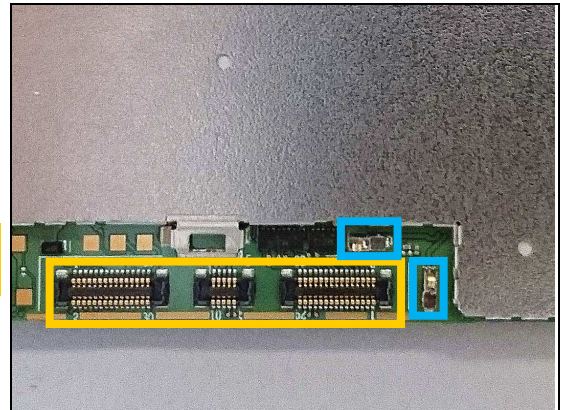
GP2601, GP2602

**Replace if mechanical damaged (No or bad NFC)
Protect the BtB connectors with capton tape!**

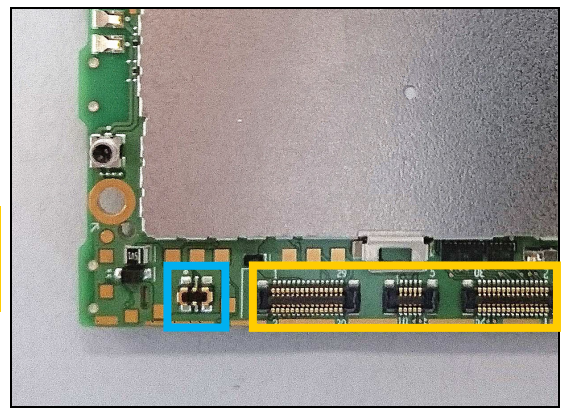
J1001

**Replace if mechanical damaged (Phone dead or power off)
Protect the BtB connectors with capton tape!**

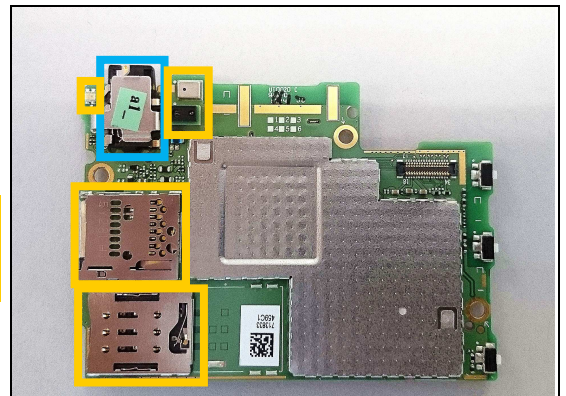
J1601

**Replace if no audio from headset.
Protect the notification LED, Mic, Proximity sensor, SD and SIM connector with capton tape!**

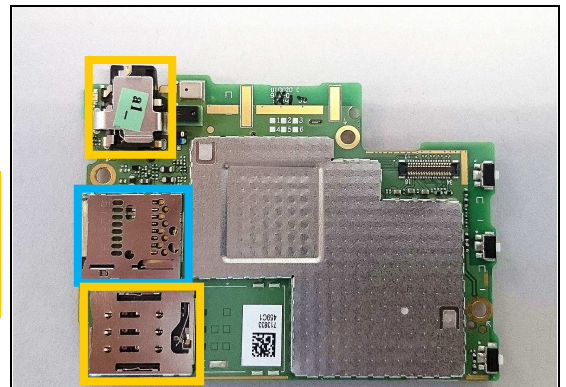
J2801

**Replace if mechanical damaged.
(No SD card inserted)
Protect the Audio Jack and SIM connector with capton tape!**

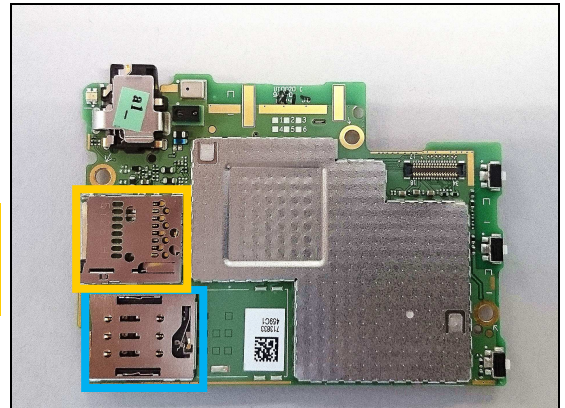
J2901

Replace if mechanical damaged.

(No SIM card inserted)

Protect the SD connector with capton tape!

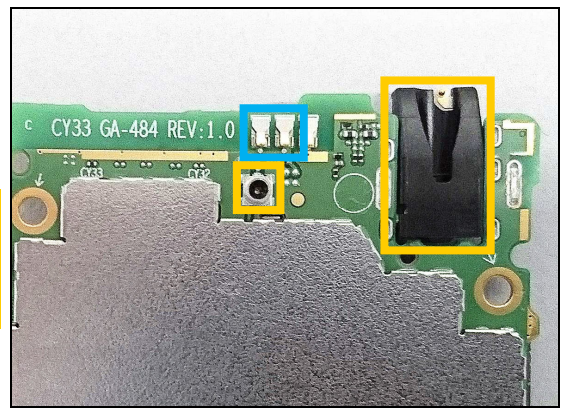
PAD2401, PAD2403

Replace if mechanical damaged (Bad network, diversity Rx antenna)

Protect the RF connector and Audio Jack with capton tape!

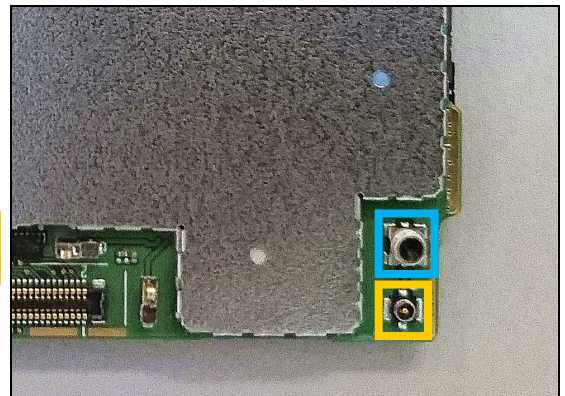
SMA2301

Replace if open circuit 1-2 (Bad network, Main antenna)

Protect the RF connector with capton tape!

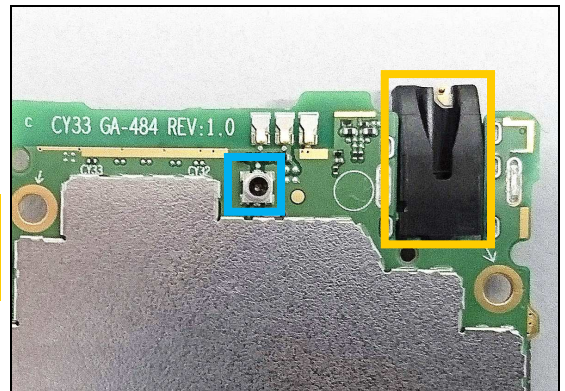
SMA2401

Replace if open circuit 1-2 (Bad network, diversity Rx antenna)

Protect the Audio Jack with capton tape!

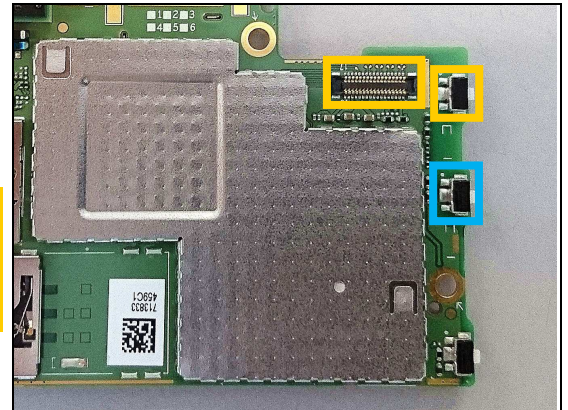
SW1901

Replace if mechanical damaged or open circuit 1-2 when pushed.
(Volume down problems)
Protect the BtB connector and switch with capton tape!

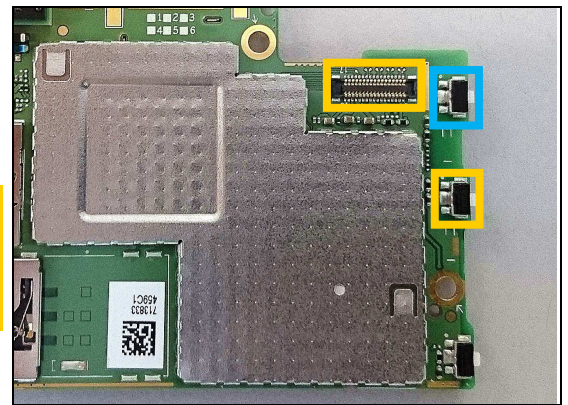
Replace if mechanical damaged or open circuit 1-2 when pushed.
(Volume up problems)
Protect the BtB connector and switch with capton tape!

SW1902	SWITCH	2322000086W	P HA+BH ⇨14
SW1903	SWITCH	2322000086W	P HA+BH ⇨15
U301	MEMS MIC	2220000073W	P HA+BH or BGA ⇨16

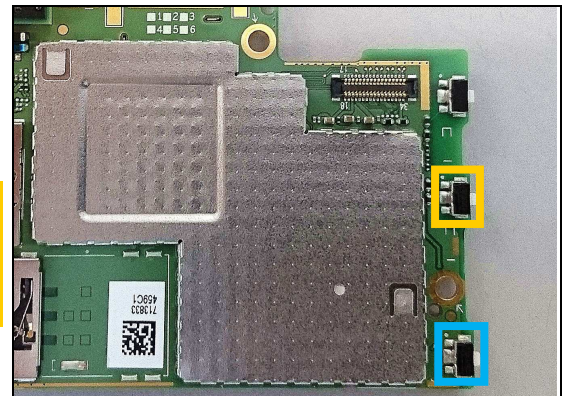
SW1903

Replace if mechanical damaged or open circuit 1-2 when pushed.
(Power on problems)
Protect the switch with capton tape!

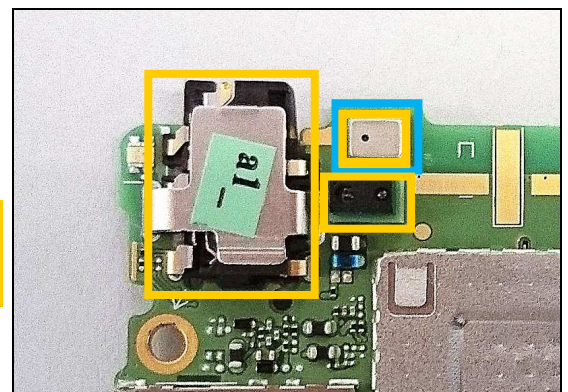
U301

Replace if no audio from secondary mic.
When replacing protect secondary mic, Proximity-sensor and Audio Jack with capton tape!
