Trouble shooting guide, Electrical

Applicable for Z1010

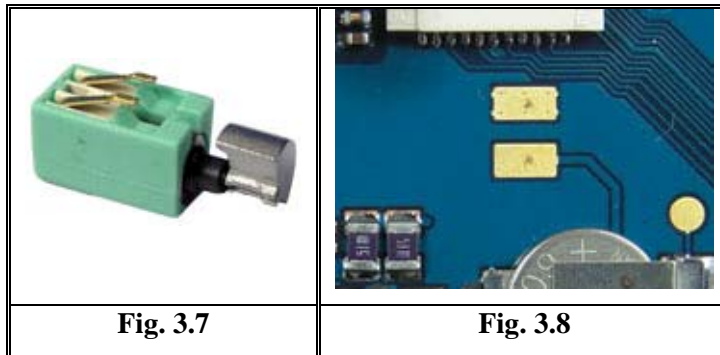
- Turn on the phone. Go to the service test menu (1.1); choose “Vibrator”. Press any key to check that the vibrator works properly.
- Check if the vibrator (*Fig. 3.7*) is mechanically damaged, dirty or oxidized. Replace it if necessary.
- Check if the vibrator pads (*Fig. 3.8*) are dirty or oxidized. Clean them if necessary.

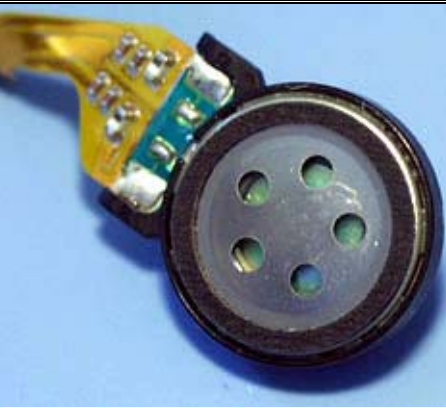
Fig. 4.1

- Turn on the phone. Go to the service test menu (1.1); choose “Earphone”. Press any key to check the speaker.
- Check if the speaker (*Fig. 4.1*) is mechanically damaged, dirty or oxidized. Replace it if necessary.
- Check if the speaker gasket (*Fig. 4.2*) is mechanically damaged. Replace it if necessary.
- Check if the flex film (*Fig. 4.4*) is mechanically damaged. Replace it if necessary.
- Check if the FPC Connector 33pu 085 (*Fig. 4.5*) is closed and if it is mechanically damaged, dirty or oxidized. Replace it if necessary.
- Check if the Sub PCB assembly (*Fig. 4.6*) is mechanically damaged, dirty or oxidized. Replace it if necessary.
- If the fault still occurs, replace N2300 (Knatte 2).

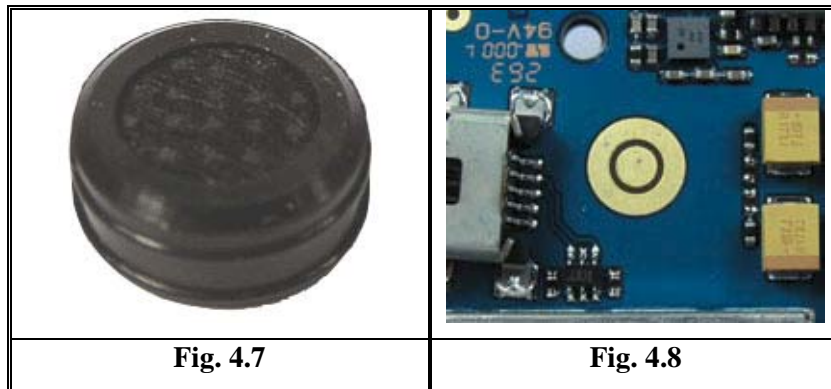
- Insert a working SIM card into the Z1010 and turn it on; make a call to the phone.
- Check if the microphone (*Fig. 4.7*) is mechanically damaged, dirty or oxidized. Replace it if necessary.
- Check if the microphone pads (*Fig.4.8*) are dirty or oxidized. Clean them if necessary.
- If the fault still occurs, replace N2300 (Knatte 2).

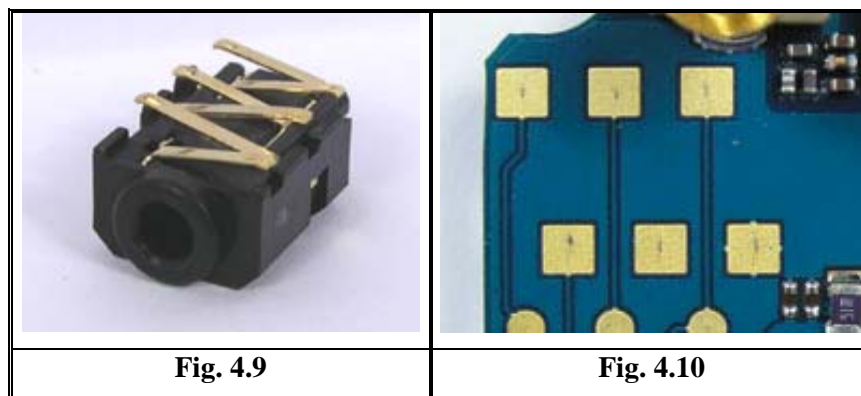
- Insert a working headset to the Audio jack connector.
- Insert a working SIM card into the Z1010 and turn it on; make a call to the phone.
- Check if there is sound from the earphone and microphone is working. Replace the Audio jack connector (*Fig. 4.9*) if necessary.
- Check if the Audio jack connector pads on the Main PCB (*Fig. 4.10*) are dirty or oxidized. Clean them if necessary.

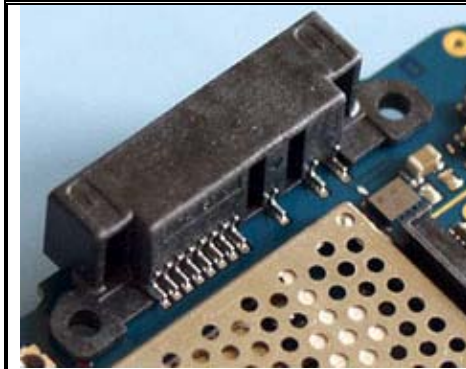
Fig. 6.1

- Check if the system connector X2302 (*Fig. 6.1*) is mechanically damaged, dirty or oxidized. Replace it if necessary
- If the fault still occurs, try to replace N2300 (Knatte2)

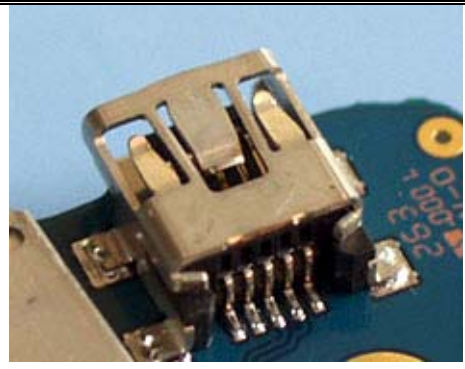
Fig. 6.2

- Check if the USB connector X2500 (*Fig. 6.2*) is mechanically damaged, dirty or oxidized. Replace it if necessary.

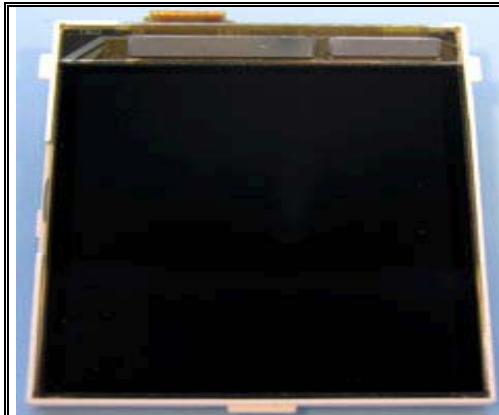
Fig 8.1

- Turn on the phone. Go to the service test menu (1.1); choose “Main screen”.
- Check if the main LCD (*Fig 8.1*) is working properly and if there are missing lines or discolours. Replace it if necessary.
- Check if the flex film (*Fig 8.4*) is mechanically damaged. Replace it if necessary.
- Check if the FPC Connector 33pu 085 (*Fig. 8.5*) is closed and if it is mechanically damaged, dirty or oxidized. Replace it if necessary.
- Check if the Sub PCB assembly (*Fig. 8.6*) is mechanically damaged, dirty or oxidized. Replace it if necessary.

- Turn on the phone. Go to the service test menu (1.1); choose “LED/Illumination”.
- Check if the illumination is balanced all over the Main LCD (*Fig. 8.1*). Replace the Main LCD if necessary.
- Check if the illumination is balanced all over the Sub LCD (*Fig 8.2*). Replace the Sub LCD if necessary.
- Check if the flex film (*Fig 8.4*) is mechanically damaged. Replace it if necessary.
- Check if the FPC Connector 33pu 085 (*Fig. 8.5*) is closed and if it is mechanically damaged, dirty or oxidized. Replace it if necessary.

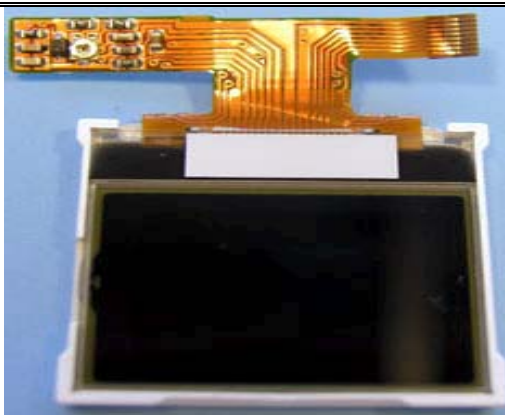
Fig 8.2

- Turn on the phone. Go to the service test menu (1.1); choose “Outside display”.
- Check if the Status LCD (*Fig 8.2*) is working properly and if there are missing lines or rows. Replace it if necessary.
- Check if the flex film (*Fig 8.4*) is mechanically damaged. Replace it if necessary.
- Check if the FPC Connector 33pu 085 (*Fig. 8.5*) is closed and if it is mechanically damaged, dirty or oxidized. Replace it if necessary.
- Check if the Sub PCB assembly (*Fig. 8.6*) is mechanically damaged, dirty or oxidized. Replace it if necessary.

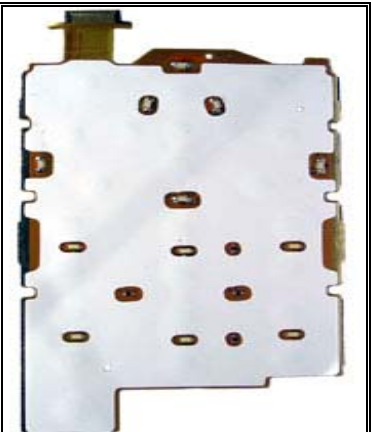
Fig 8.3

- Check if the Sub PCB assembly (*Fig. 8.6*) is mechanically damaged, dirty or oxidized. Replace it if necessary.
- Check if the illumination is balanced in all the keys. Replace the keyboard PCB (*Fig. 8.3*) if necessary.

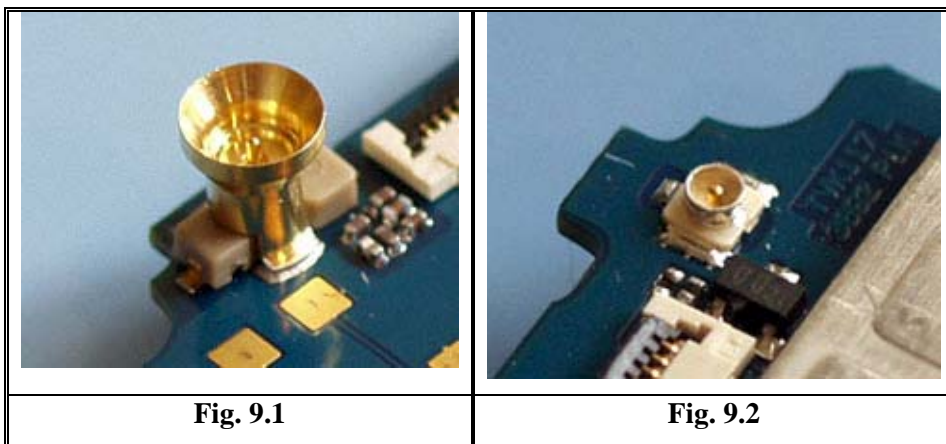
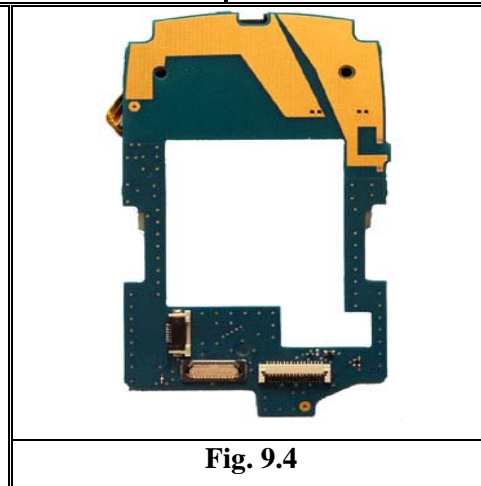
- Check if the external antenna connector W1001 (*Fig. 9.1*) is mechanically damaged, dirty or oxidized. Measure the resistance of the external antenna connector W1001; it should be less than 1Ω. Replace it is necessary.

- Check if the coax connector (*Fig. 9.2*) is mechanically damaged, dirty or oxidized. Replace it if necessary.
- Check if the antenna switch is mechanically damaged, dirty or oxidized. Replace it if necessary.

- Check if the Sub PCB assembly (*Fig. 9.4*) is mechanically damaged, dirty or oxidized. Replace it if necessary.

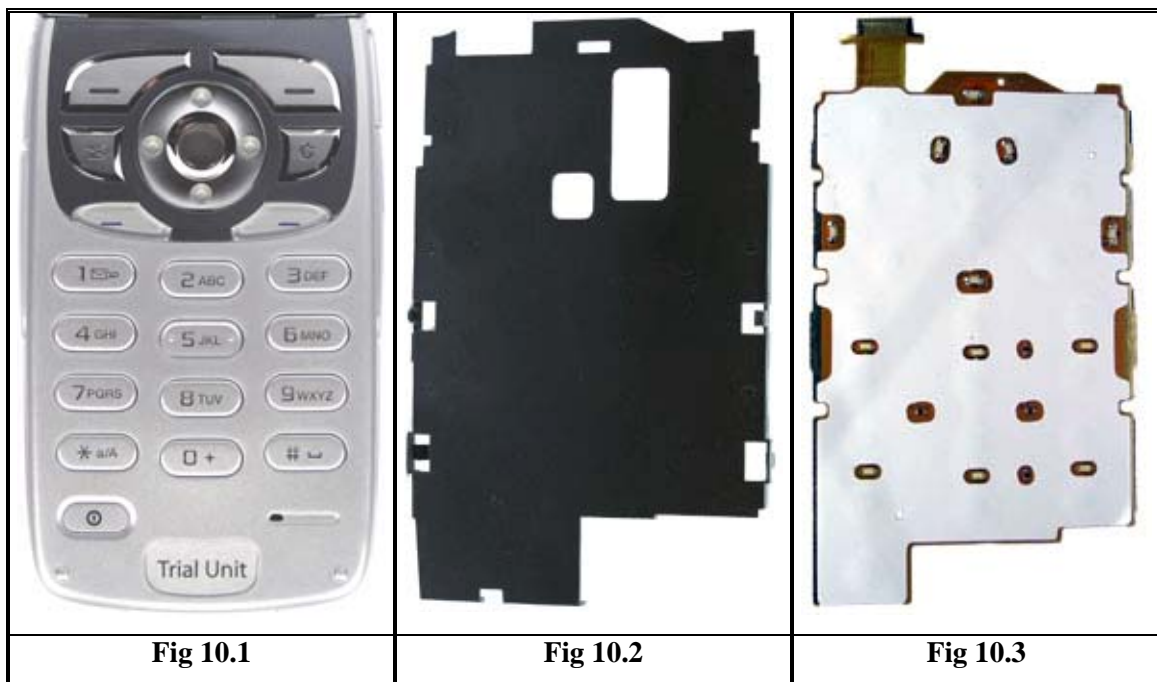
- Turn on the phone using a working battery. If it fails;
- Check if the On/Off key (*Fig. 10.1*) is working properly. Check if the mechanical response feels normal. Replace the keyboard (*Fig. 10.1*), the keyboard support (*Fig. 10.2*) or the keyboard PCB (*Fig. 10.3*) if necessary.

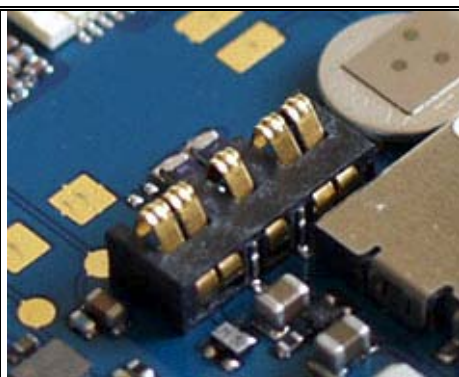
Fig 10.5

- Turn on the phone with the customer's battery. If it fails, connect a charger to the phone, if the battery voltage is too low the phone will charge the battery without turning on the phone (this will usual not take more than 10 minutes) and when the battery voltage is high enough the phone will be able to turn on and show charging in the LCD. If it still fails to turn on;
- Check if the battery (*Fig. 10.4*) is working properly. Replace it if necessary.
- Check if the battery connector X2200 (*Fig. 10.5*) is mechanically damaged, dirty or oxidized. Replace it if necessary.

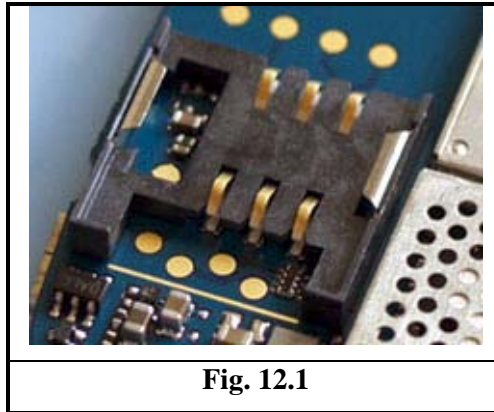
Fig. 12.1

- Make a general visual inspection for corrosion and oxidation caused by liquid damage according to point 1.2
- Insert a working SIM card to the phone and turn it on.
- If the display shows “Insert card”, there is a SIM problem, if it shows “Insert correct card”, the phone might be SIM locked in this case try to use a test SIM card.
- Check if the SIM-reader X2300 (*Fig. 12.1*) is not mechanically damaged, dirty or oxidized. Replace it if necessary.
